# Carpenter Ants

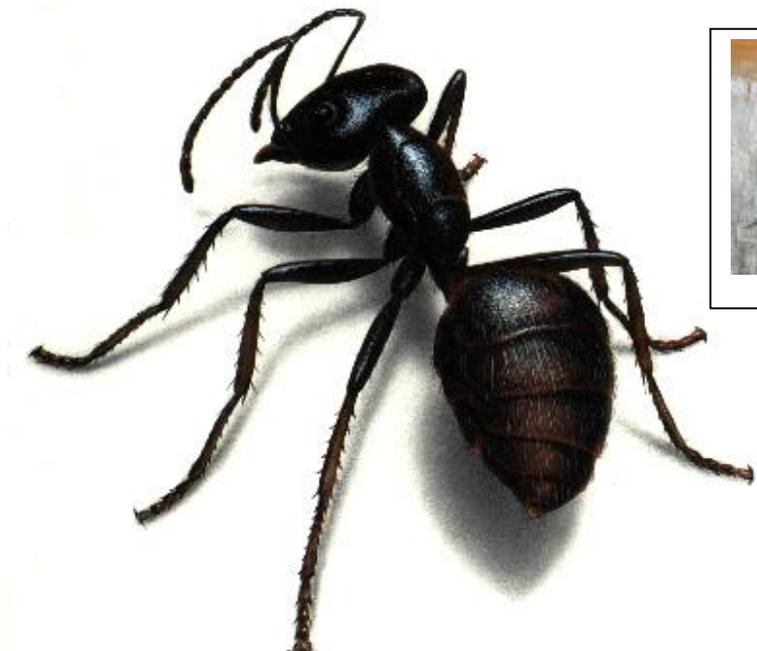
ant damage

**Any type of home or structure can be infested.** Among commonly mined portions are porch pillars, supporting timbers, sill plates, joists, studs and casings. They also nest in wall voids and ceiling insulation. A common location for a nest is in a wall on the ground floor of a kitchen near a dishwasher. They are easiest to control when the nest is new and localized. When ants are well-established and in particular, when they are in flat roofs or open-beam ceilings, it can be very difficult. If the colony is large and well-established, repairs may be required. Sometimes, there is a moisture condition or rot-problem needing correction. Ants may find these conditions attractive.
